Mews Structure

ARCHITECTURE
CONSERVATION
ARCHITECTS

Comments on Proposed Addition of [redacted] to the Record of Protected Structures

February 2022

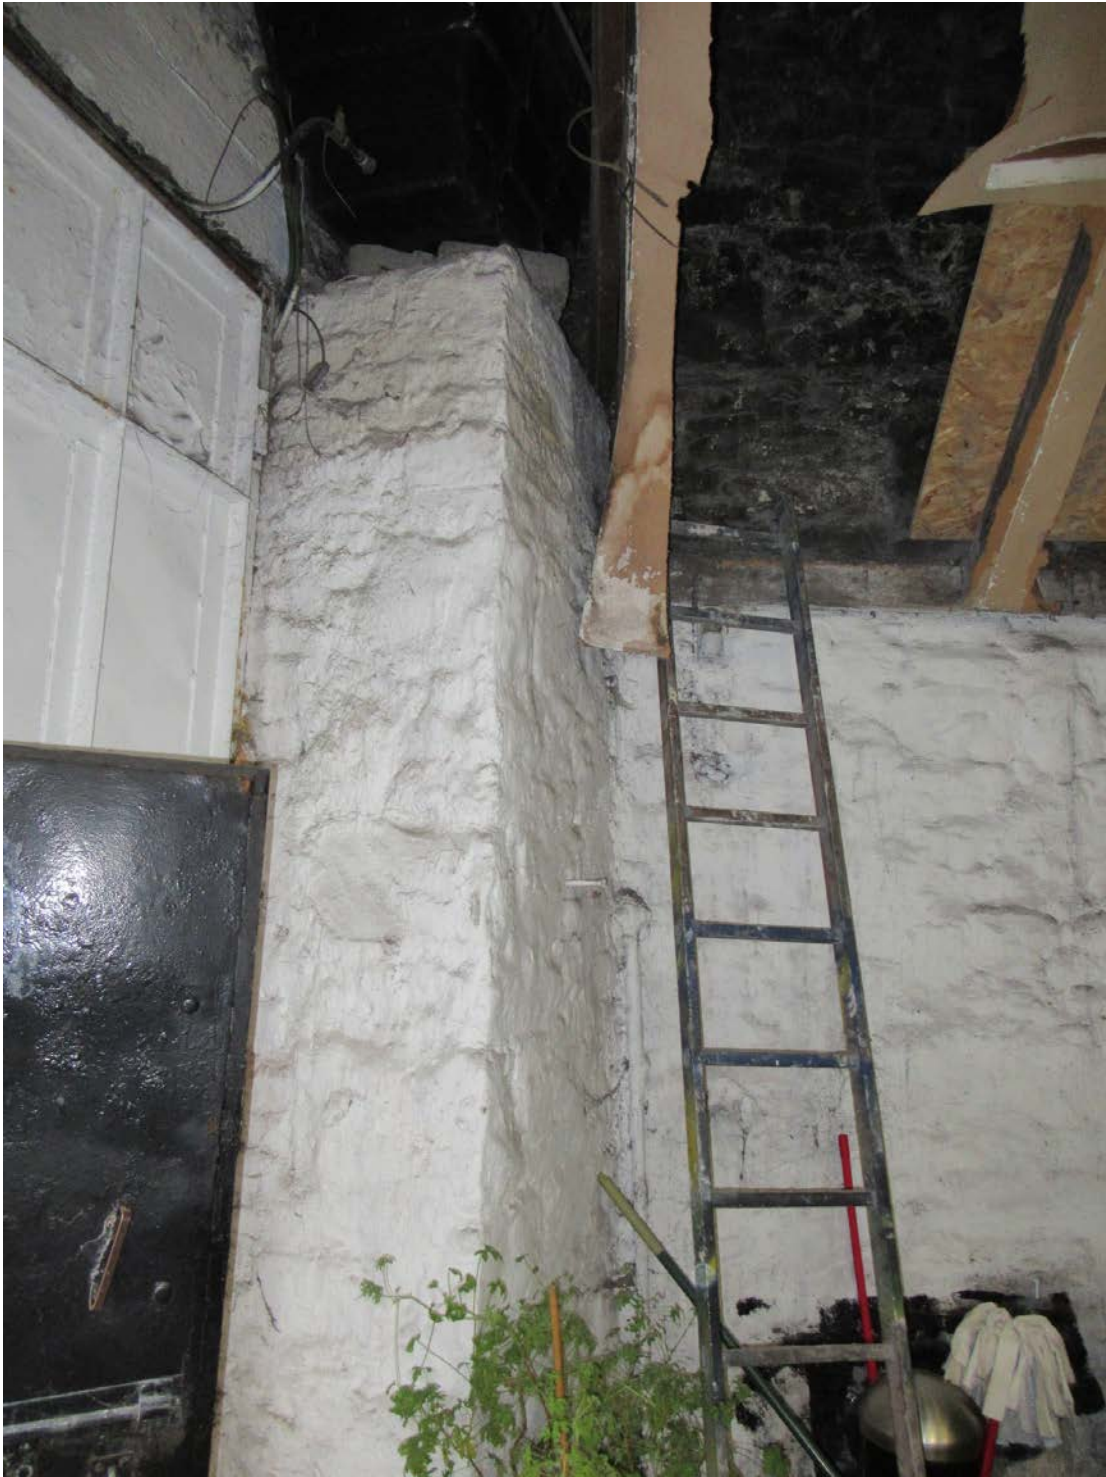
Figure No. 8. Internal detail view showing the rubble stone pier that forms the northeast corner to the current structure at [REDACTED]. This pier also forms the east jamb to the large vehicular gate. The old rubble stone wall behind this pier can be seen to continue across behind this pier to the corner, suggesting that they were not built at the same time.

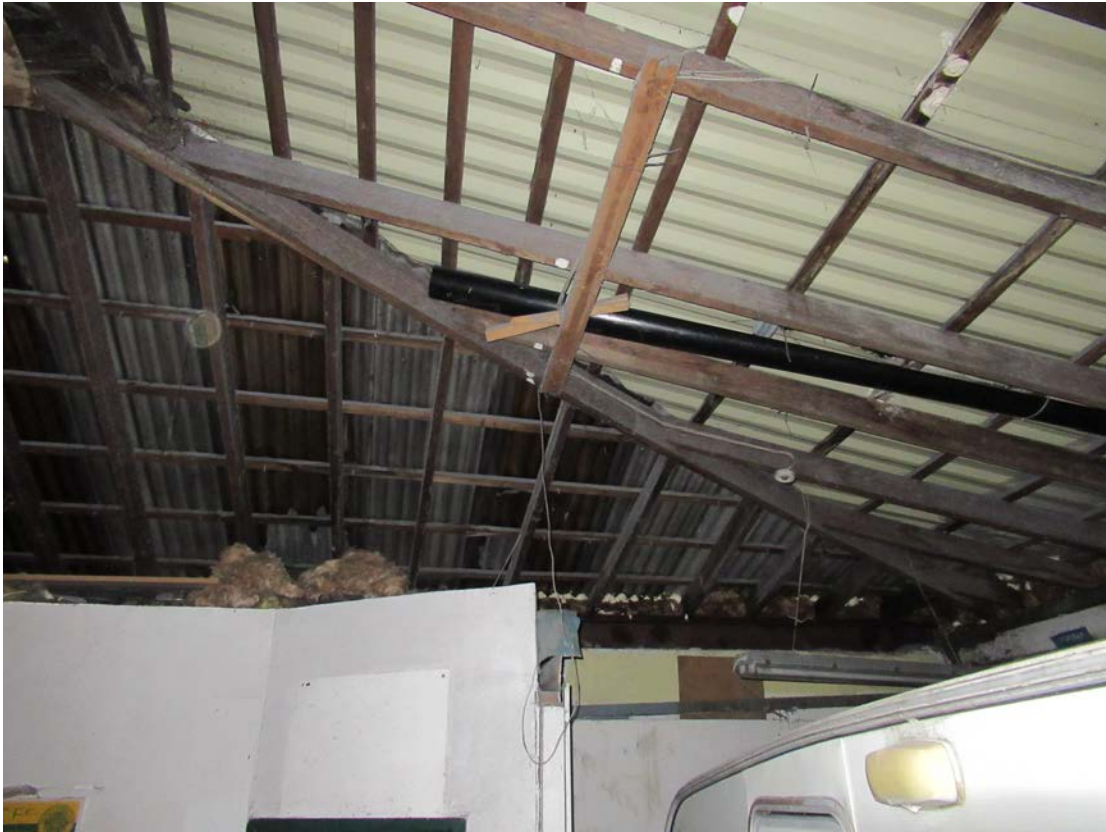
The roof over Ms. Driscoll's property consists of a simple cut-timber structure, covered with corrugated steel and aluminium sheet roofing. This roof appears to date from the C20th century, with some repairs having been carried out at various later dates. No part of this roof appears to date from the C18th or C19th century, and it covers an area that was originally an open stable yard. The floor inside Ms. Driscoll's property is covered by a concrete slab, of unknown age, but obviously not dating from the C18th or C19th.

Figure No. 9. Internal view showing the lightweight timber roof structure to [REDACTED], covered with corrugated steel and aluminium sheeting. This roof contains no materials that could date from the C18th or early C19th, and appears to have been built and repaired since the middle of the C20th.
